# *Operation* **UPSHOT-KNOTHOLE** NEVADA PROVING GROUNDS

EFFECTS OF AN ATOMIC EXPLOSION ON TWO TYPICAL  
TWO-STORY-AND-BASEMENT WOOD-FRAME HOUSES

# **EFFECTS OF AN ATOMIC EXPLOSION ON TWO TYPICAL TWO-STORY-AND-BASEMENT WOOD-FRAME HOUSES**

Federal Civil Defense Administration  
Washington, D. C.  
September 1953

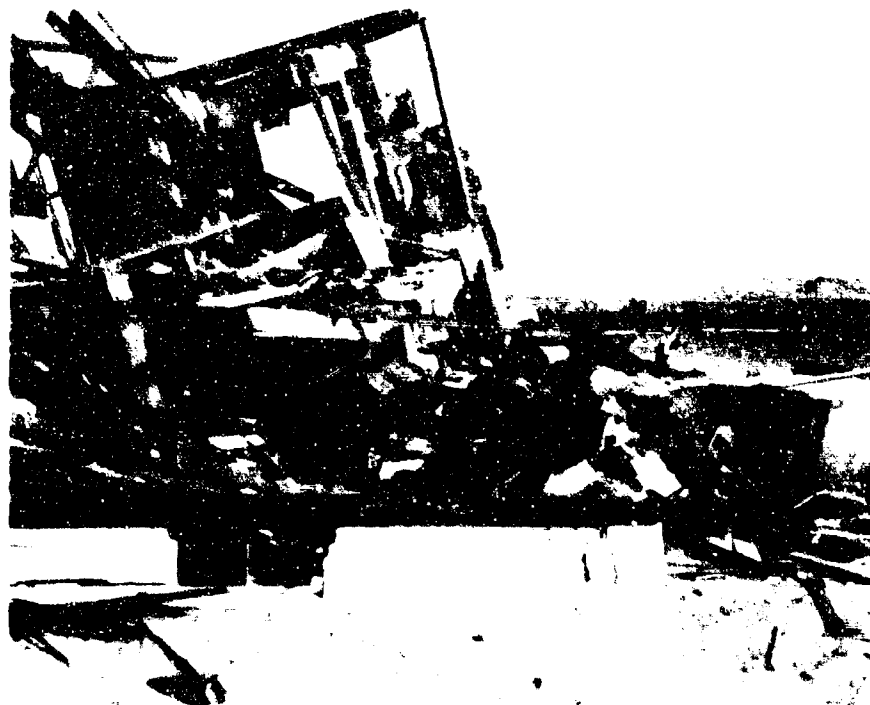
Fig. 2.57—Front foundation wall above grade after the blast.

The foundation wall above grade suffered little damage on the front and sides but was damaged at the rear by the movement of the first-floor system. However, the front foundation wall (Fig. 2.57) was cracked through vertically from sill to basement floor at each end, about 1 ft from the corner, and was moved in at the top about 1 in., hinging at the basement floor level. The hinged wall showed no bowing or cracking, however. Lateral earth pressure due to the pressure on the ground in front of the house was the most probable cause of this effect.
